## Troubleshooting chip component solder balls

### A tale of fresh eyes, red herrings and dirty tweezers...

Published in CIRCUITS ASSEMBLY

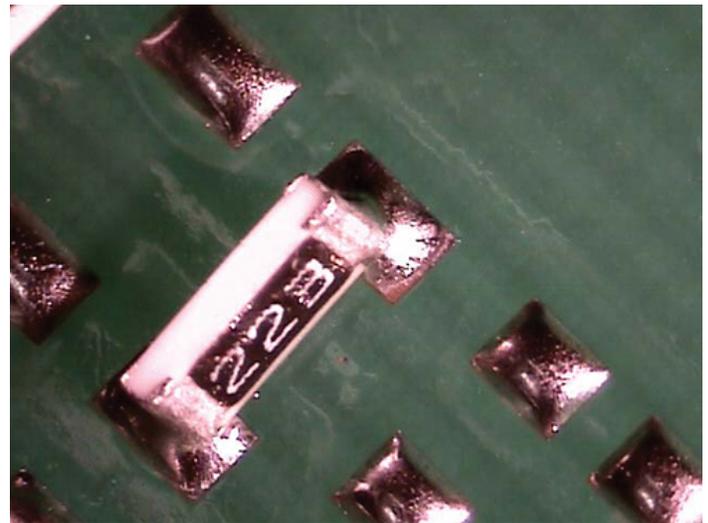
**FIGURE 1.** Component billboarding, where the part stands on its side.

We optimized a profile for the board and got QA's approval to begin production, but upon starting we immediately ran into an issue. The component with the solder balling problem was also "billboarding" (**FIGURE 1**). The billboard defect, in which a chip component stands on its side (unlike a tombstone, which stands on one end), is typically not a reflow problem, but rather a placement issue caused by mispicking the part.

Before heading back to the P&P to check the feeder, tape and nozzles, we asked the inspector if this defect was also common. We were told that the billboard was not a defect, but part of the customer's specification. Sure enough, the component was being correctly placed by the P&P, and then an operator would use tweezers to manually flip the component on its side per the spec. We don't know why

Dirty tweezers... go figure. Not printing, not placement, not profile, not outgassing – just a dirty hand tool. All the remote troubleshooting in the world would not have pinpointed this root cause. Had the reflow Guru ignored the billboard as an unrelated placement defect, we'd have missed it. This was one of those problems that just needed a fresh set of eyes and the tenacity to investigate every clue. Oh, and clean tweezers.

We provided the operator a clean pair of tweezers and emphasized the importance of a steady hand, explaining that stray solder paste on the component becomes solder balls that are considered defects and must be removed. We started up the line and built a five-board sample with the optimized profile, clean tweezers and a new understanding. QA approved them with flying colors, and the assembly line returned to production with the solderballing defect in check.
