AIM

SMT Troubleshooting Guide

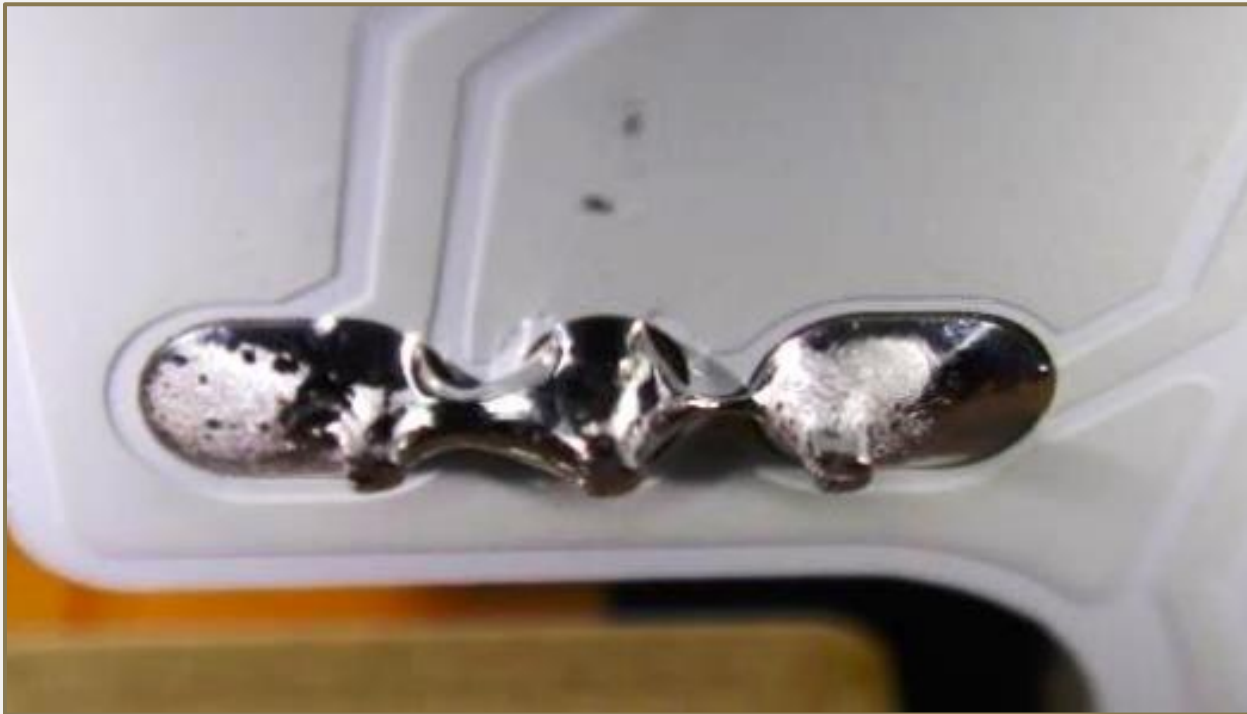
Bridging

- ▶ Recognized by solder running from one component contact to another. This could result in a short circuit

- » Cold slump - due to paste being the incorrect viscosity or too rapid squeegee speed resulting in over shearing of solder paste and degrading its thickeners

- » Check viscosity of the paste. If correct, lower print speed and run fresh paste to see if problem persists
- » Might be humidity related. Use of fresh paste is recommended

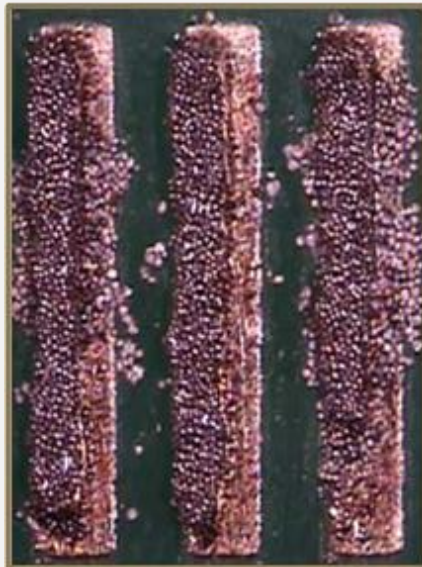
Bridging

- » Excess of solder paste being deposited on the pads between the bridge. Upon reflow, the excess solder may flow over to adjacent pad

- » Reduce aperture dimensions or stencil thickness

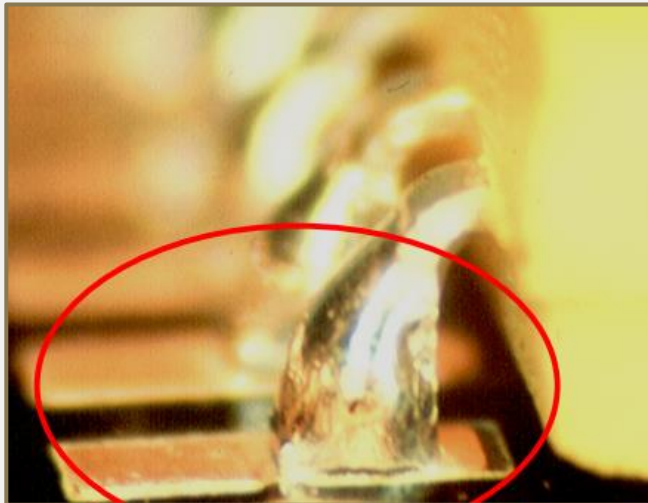
Opens or Insufficient Fillet

- » Solder paste viscosity is too high not allowing paste to roll on the stencil and/or fill the apertures
- » Separation speed too fast
- » Separation distance too small
- » Poor stencil cut

- » Check viscosity and metal content to see if manufacturer's specifications are met
- » Check other settings one by one until solution is found
